USAAMRDL TECHNICAL REPORT 71-47

EVALUATION OF THE UH-1D/H HELICOPTER CRASHWORTHY FUEL SYSTEM IN A CRASH ENVIRONMENT

November 1971

**CONTRACT DAAJ02-69-C-0030
DYNAMIC SCIENCE ENGINEERING OPERATIONS
A DIVISION OF MARSHALL INDUSTRIES
PHOENIX, ARIZONA**

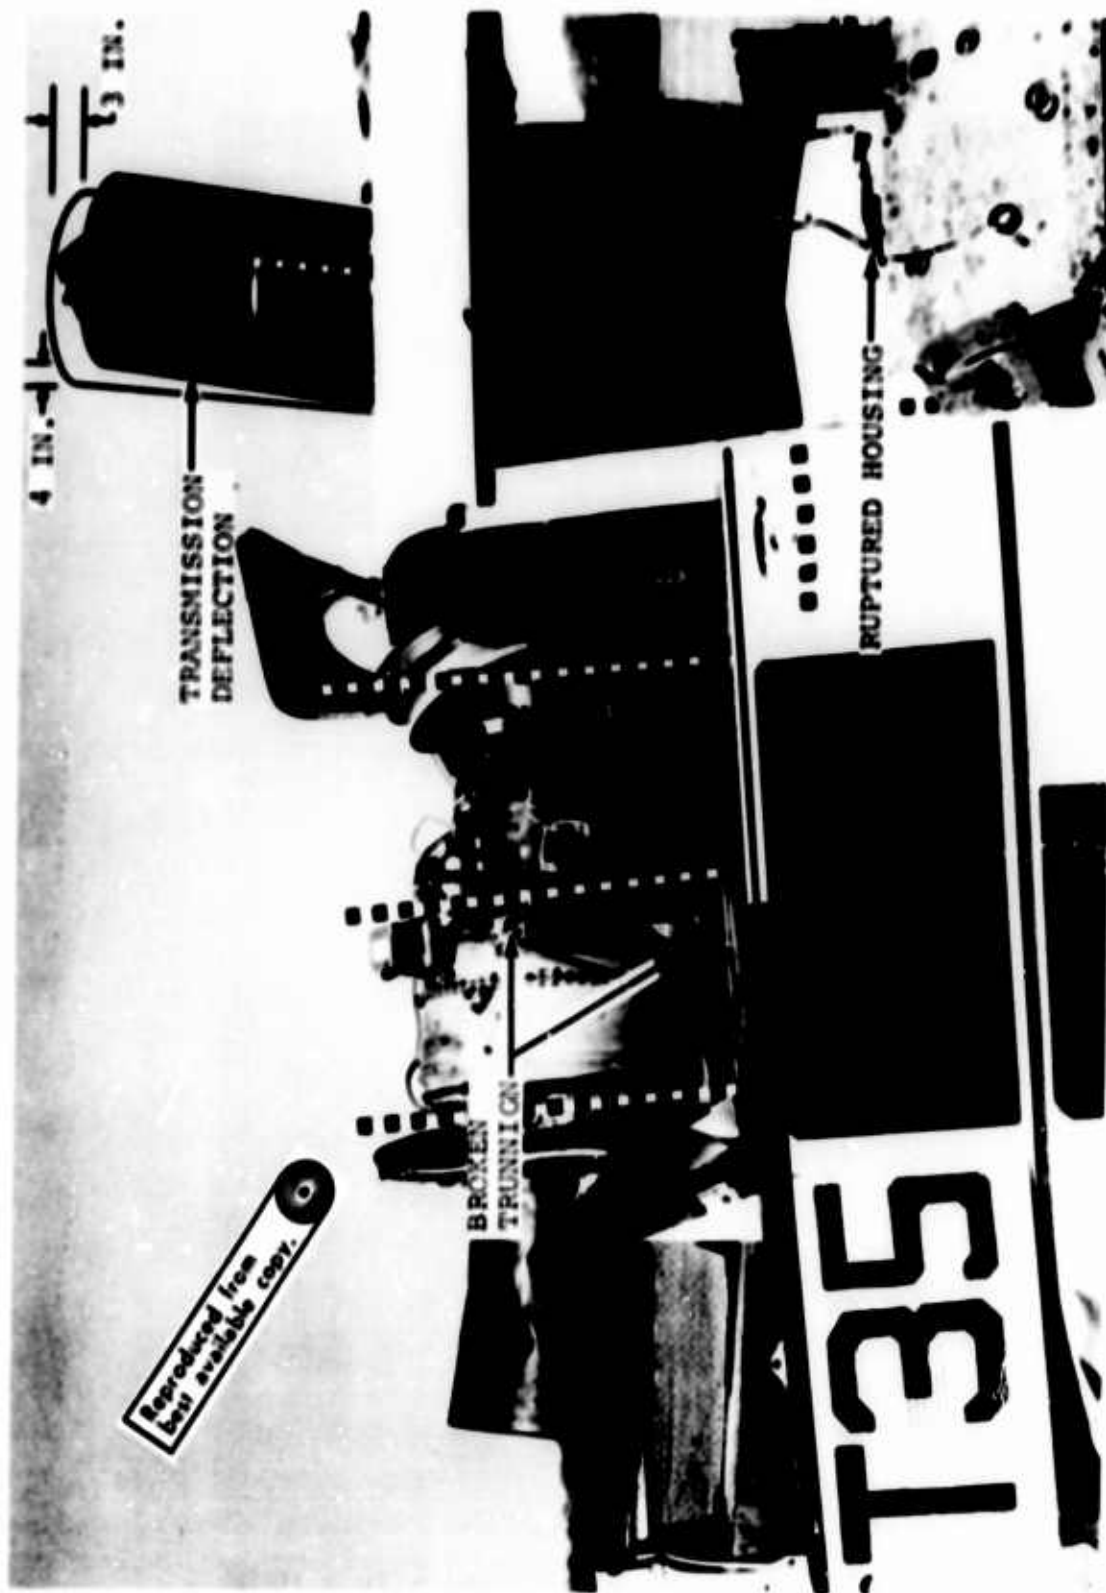
Figure 13. Engine and Transmission Deflection (Test 1).

The transmission deflected downward 3 inches at the base and approximately 4 inches forward at the point of exit from the top of the fuselage. The downward force of the transmission induced failure of the right side panel of the transmission housing, causing the entire housing to shift downward about 4-1/2 inches relative to the floor as shown in Figures 13 and 14.

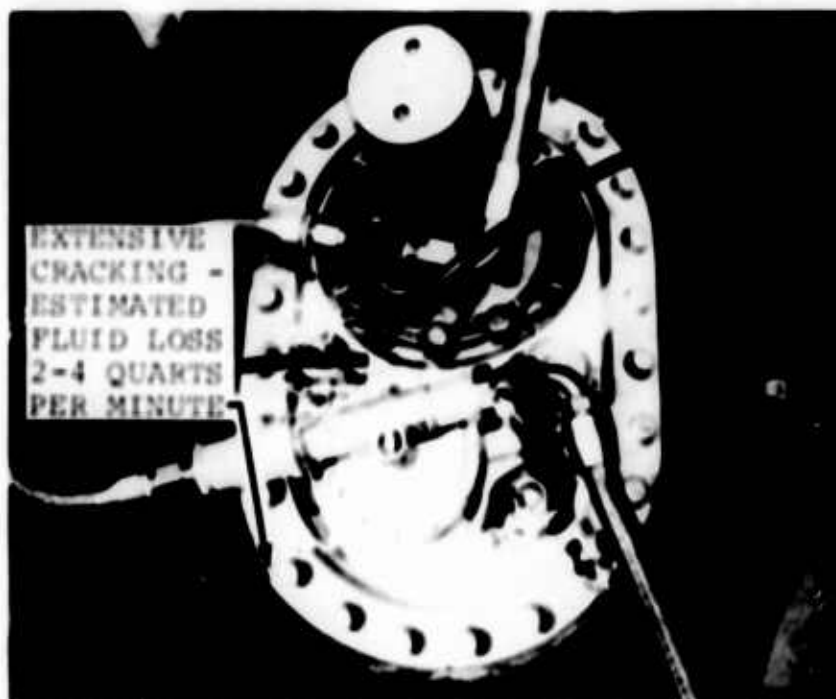
Figure 21. Damage to Right-Hand Boost Pump Plate (Test 1).

Like the left-hand tank, the right-hand tank sustained the impact without any noticeable damage to the tank itself. The rock directly under the boost pump broke the boost pump fitting in four places and cracked the base of the boost pump in three places (Figure 21). Fluid loss as a result of the damage was estimated at 2 to 4 quarts per minute. The vent valve in this cell also sheared off during the impact and both halves closed completely. The forward tie-down bolt was pulled out of the structure and remained in the tank wall. The forward cross-feed tube outlet remained in place and showed no extensive deformation in the tank area.

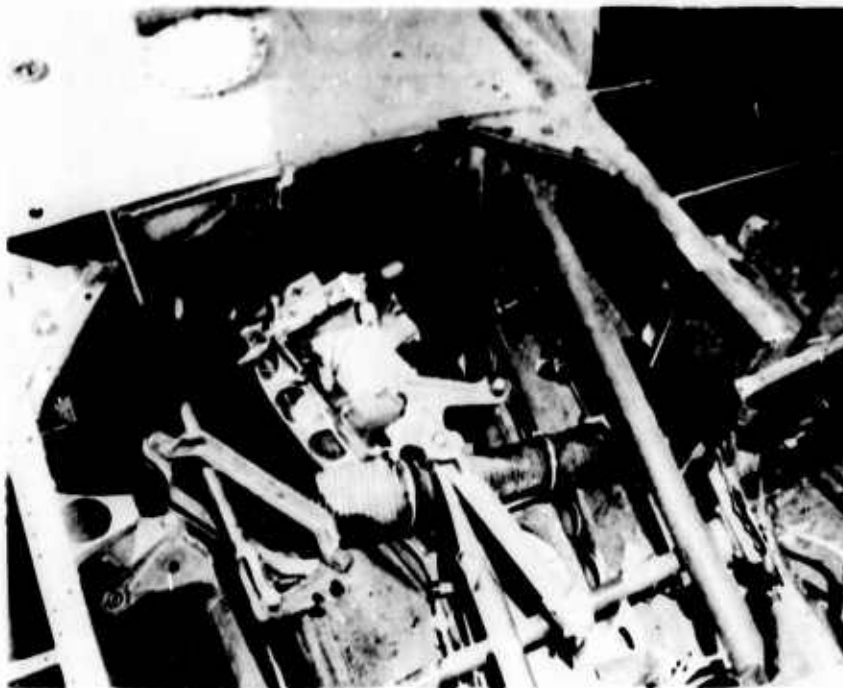
Figure 25. Forward Cross-Feed Line Failure (Test 1).

The forward cross-feed line was struck in its midsection by a boulder which caused it to separate at the fitting (Figure 25).

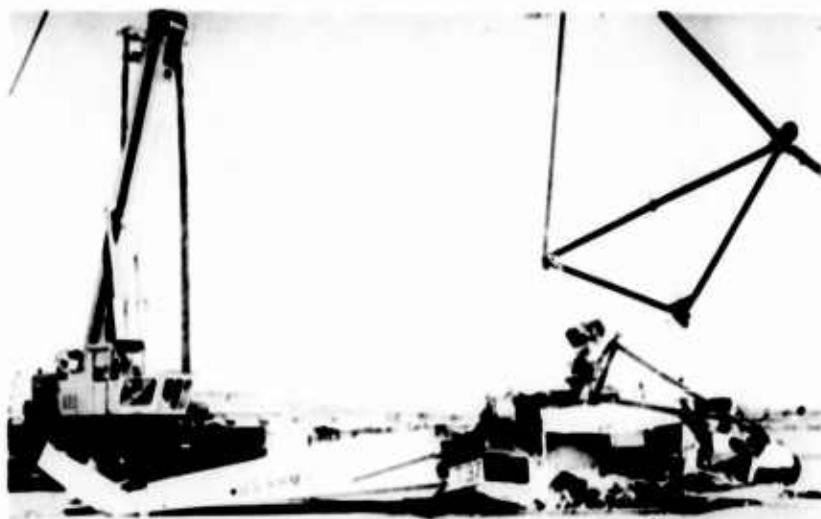
Figure 38. Posttest Attitude of Helicopter (Test 3).

A study of the high-speed films indicated the following: The test vehicle made a smooth flight from release to impact point. The actual impact attitude was close to the planned attitude as stated in the preceding paragraph. There was a slight reduction of forward velocity just before the belly touched the ground as a result of the braking effect from the stump and rock impacts. Considerable structural deformation was noted as the starboard stump drove up into the underfloor fuel cell cavity. The aircraft "bottomed" and began its rebound, but did not skid out of its impact track. The rebound was characterized by a rise at the intersection of the tail boom and fuselage while, at the same time, rolling toward the right side. This roll continued until the fuselage had rotated almost 55 degrees beyond its vertical axis, whereupon it recovered its normal orientation (Figure 38).

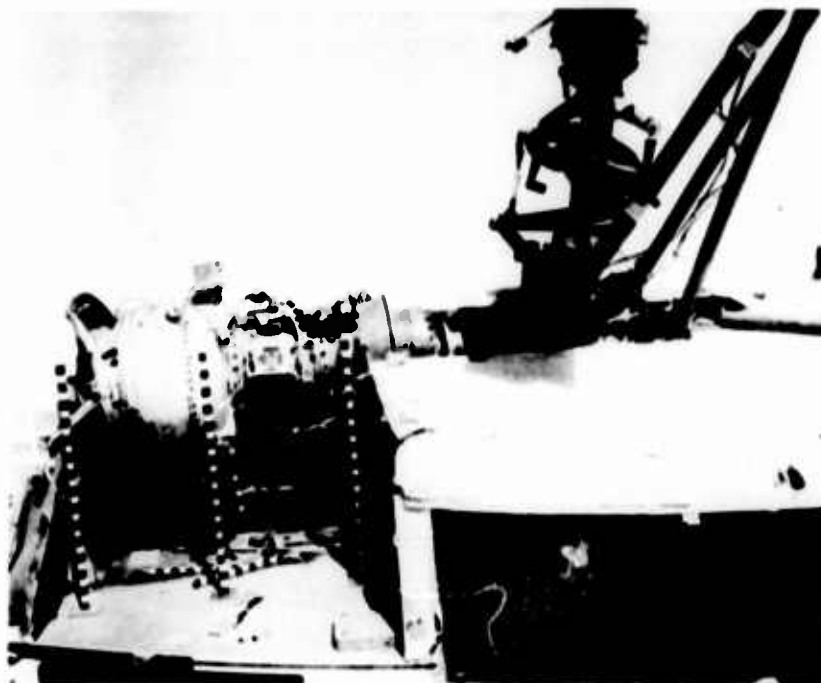
Figure 39. Posttest Position of Engine and Transmission (Test 3).

The left side engine mounts were buckled, and those on the right side were broken off. The engine had shifted forward about 3-1/3 inches, and the aft end was 5 inches below its original access position through the aft firewall (see Figure 39).

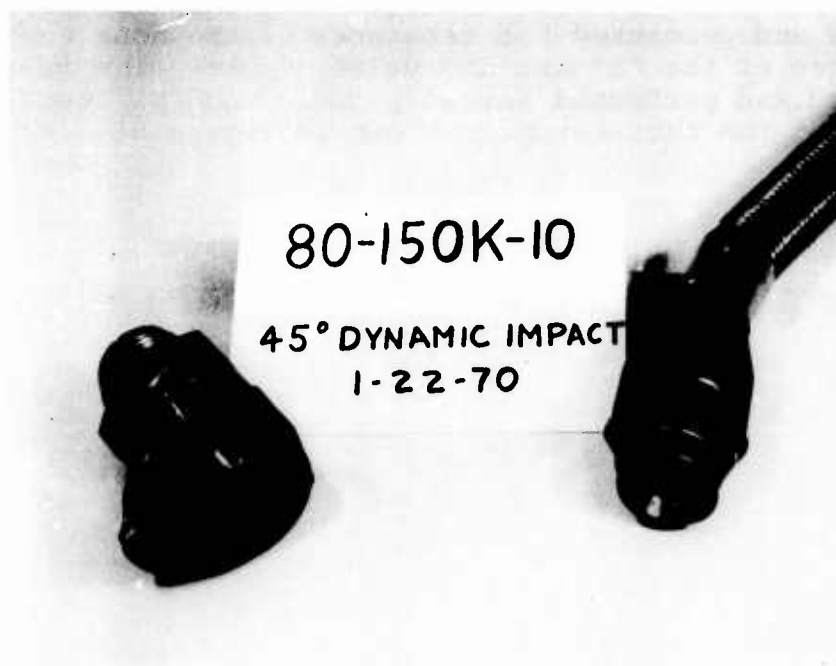
Figure 96. View of S.S.-1/2 Valve After Dynamic 45-Degree Impact Test.

leakage rate of approximately 100 cc/min. A view of the failed "B" nut is shown in Figure 96.
